Inspection Report

Property Address:
123 Any Street
Philadelphia, PA 19147

Accuracy Assured Home Inspections

Date: 2/20/2008	Time: 12:00 PM	Report ID:
Property: 123 Any Street Philadelphia, PA 19147	Customer: Mr. Joe Homeowner	Real Estate Professional:

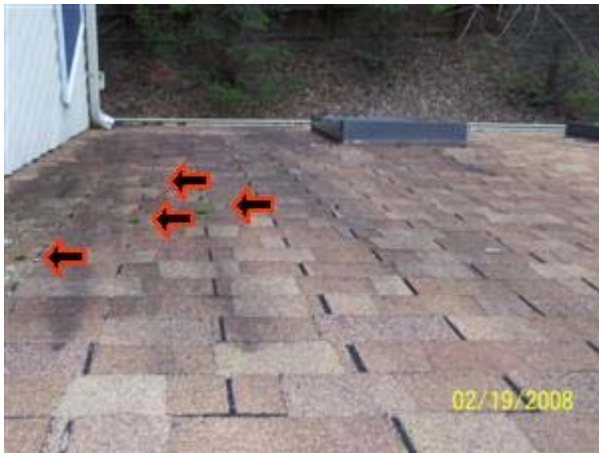
1.0 Picture 1

The roof covering was inspected from a variety of observation points. Moss was noted as growing on the rear first level roof.

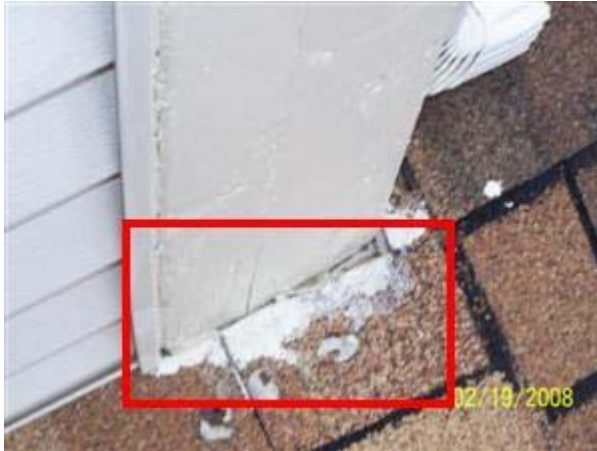
1.1 Picture 1

The flashing that was visible was inspected from the roof surface on the first level. The transition from the roof surfacing to the vertical structure was observed to be improperly sealed (Picture 1) (Picture 2) allowing a potential moisture access point. Recommend repair by a qualified roofing contractor or equivalent professional.

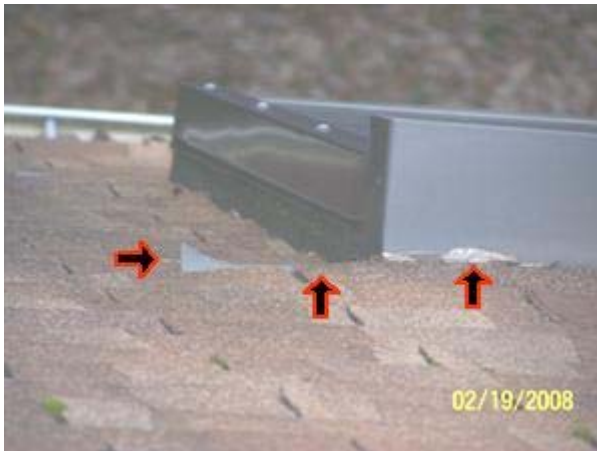
1.2 Picture 1

- 🏠 Up turned edges of flashing were observed from the ridge of the first level roof. Wind driven rain may enter under these points and cause subsequent water damage. Recommend repair by a qualified roofing contractor or equivalent professional.

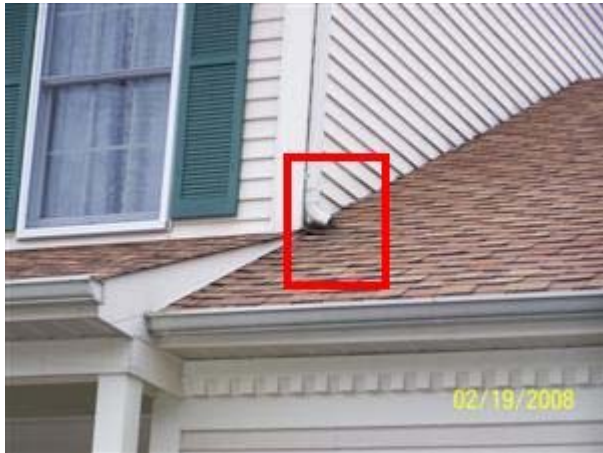
1.3 Picture 1

Several downspouts from the second level roof were noted as directly discharging onto the first level roof surface. Downspouts from higher elevated roof levels should be discharged directly into the gutter system directly below so not to prematurely wear roof coverings and cause water damage. Recommend repair by redirection of discharge point off of roof surface.(Picture 1) (Picture 2)

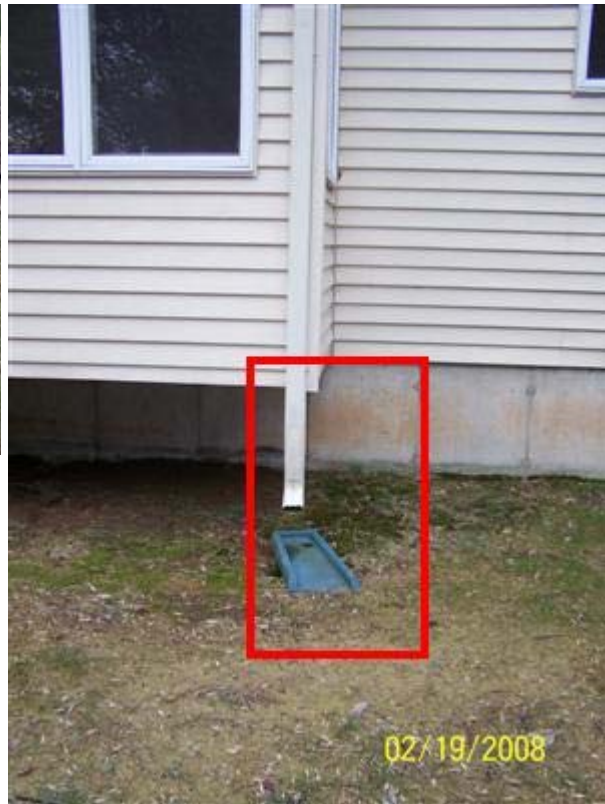
1.3 Picture 4

Downspouts from the upper level roof were noted as discharging in close proximity to the foundation walls. Recommend diverting the discharge point away from the house to prevent water damage.(Picture 3) (Picture 4) (Picture 5)

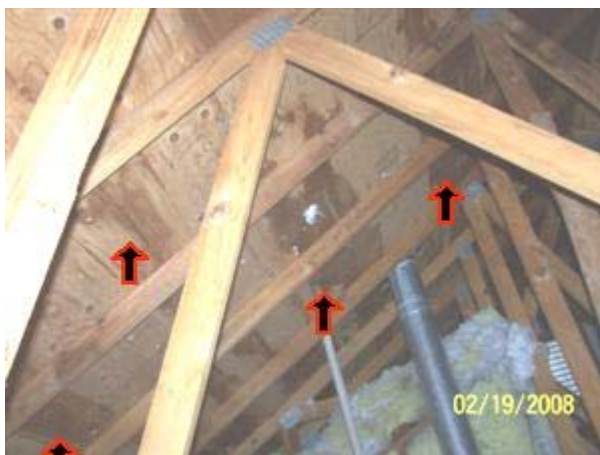
1.4 Picture 1

Staining was noted on the underside of the roof sheathing that was noted as being inconsistent with the natural wood grain. Staining appeared to be from previous water intrusion. Direct examination could not be done because of limited access to attic space and lack of supporting floor structure. Recommend further investigation by a qualified roofing contractor or equivalent professional.

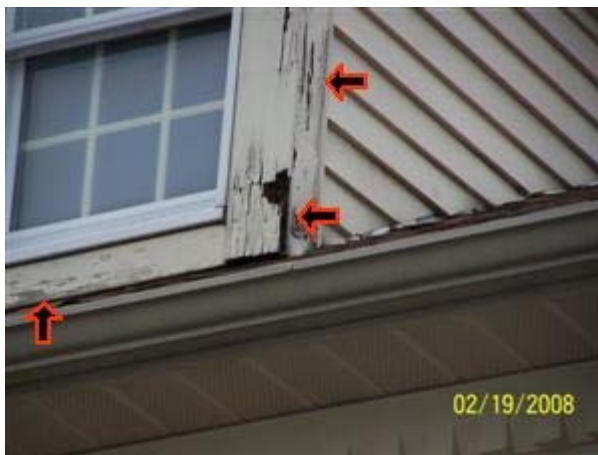
2.0 Picture 1

- Wood decay on the trim work was noted at numerous locations on the second story windows. Recommend repair and replacement.(Picture 1) (Picture 2)

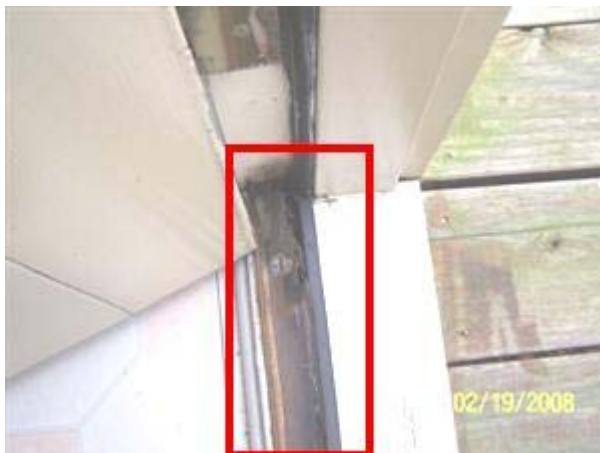
2.2 Picture 1

🏠 Wood decay was noted at the rear door threshold. Wood was extremely wet upon closer examination. Recommend repair and replacement.(Picture 1) The rear exterior door was very hard to close properly. Excessive force was needed to close the door properly so that it would latch and be locked. Recommend repair or replacement by a qualified contractor or locksmith.

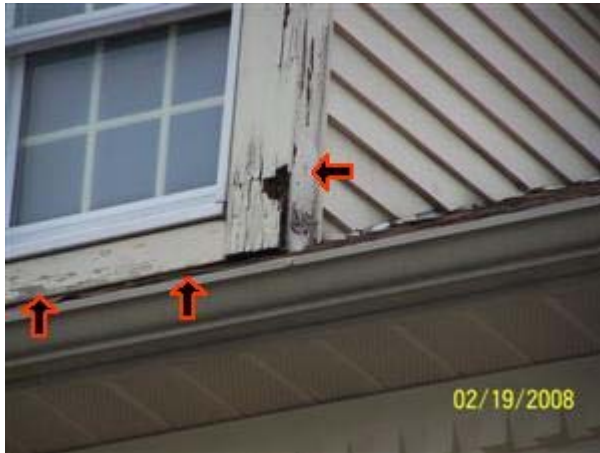
2.3 Picture 1

- 🏠 The wood trim is peeling paint at most windows. Further deterioration may occur if not repaired. I recommend a qualified contractor inspect and repair as needed.(Picture 1)

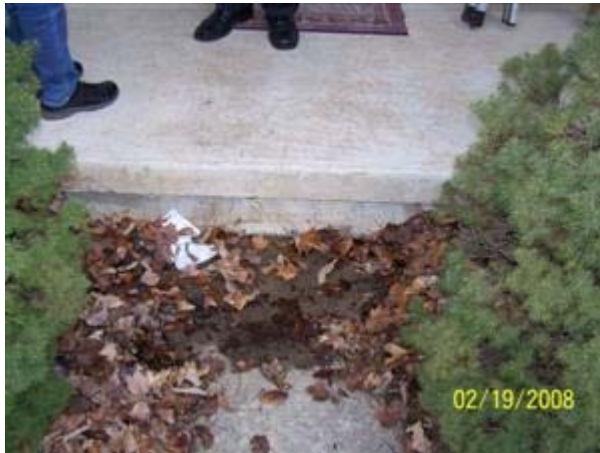
2.4 Picture 1

- 🏠 The front preachment step was observed to be a higher rise above elevation that was is typically acceptable. Recommend installing a second approachment step to prevent a safety hazard.(Picture 1)

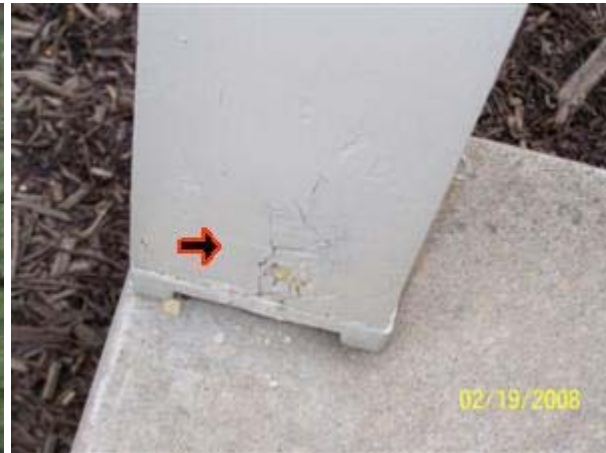
2.4 Picture 2

The posts on the front porch area were inspected and found to be repaired with a wood filler material. Uniform areas of repairs are indicative of a railing system that was removed. Recommend repair or replacement of posts that are no longer structurally sound.(Picture 2)

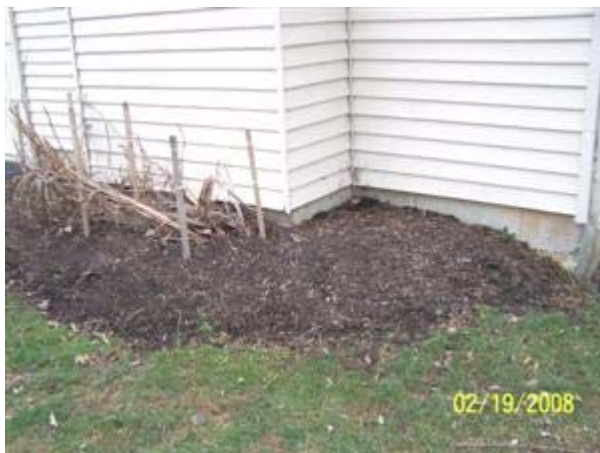
2.5 Picture 1

- 🏠 Landscaping and grading were inspected and found to be less than desirable conditions in areas. Landscaping mulch was noted as being in close proximity to the housing structure. Recommend regrading the landscaping to allow a minimum of 6 inches between any landscaping materials and the bottom edge of any siding to help prevent potential wood destroying insect infestation.(Picture 1)

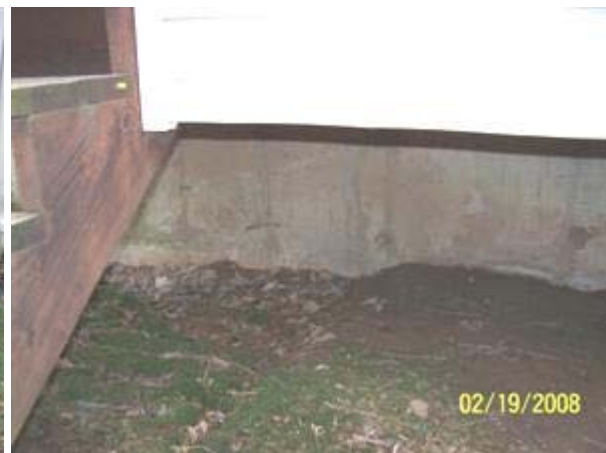
2.5 Picture 2

Drainage from run off of the back steps has created a pooling area and subsequent erosion. Recommend increasing grading to drain away from the house foundation.(Picture 2)

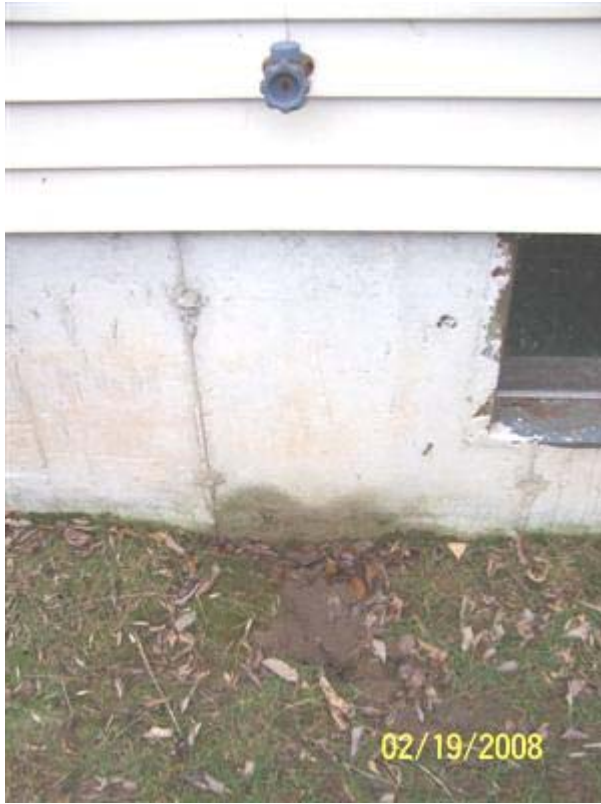
2.5 Picture 3

The hose facet fixture at the rear of the house was noted as dripping while inspecting the rear of the house. Constant dripping has lead to a pooling area and erosion. Recommend repairing the faucet and increasing the grading to drain away from the house foundation.(Picture 3) (Picture 4)

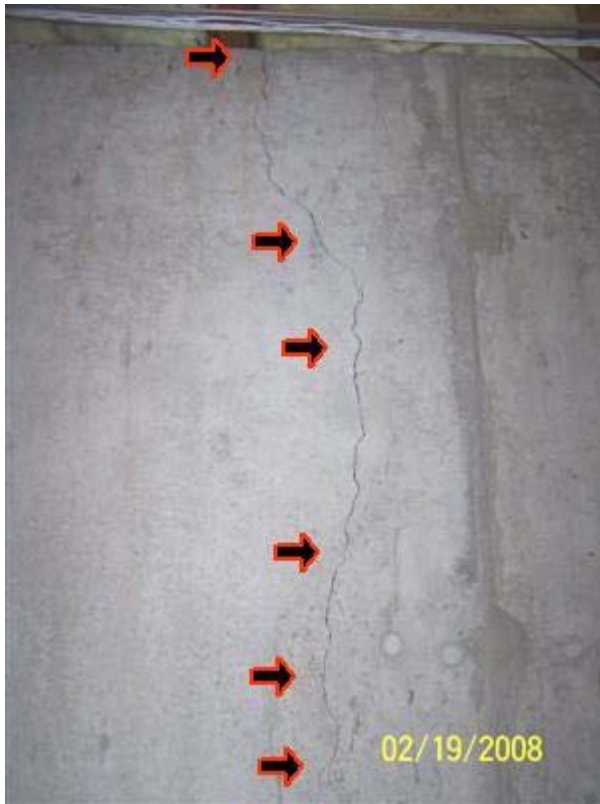
3.1 Picture 1

A large crack in the foundation wall towards the front of the house. Upon closer inspection with an inspection mirror, the top edge of the crack appeared to penetrate several inches deep. The full extent of the depth of the crack could not be fully determined. Recommend further evaluation by a structural engineer or qualified contractor to determine the full extent of the damage and possible repair options.(Picture 1)

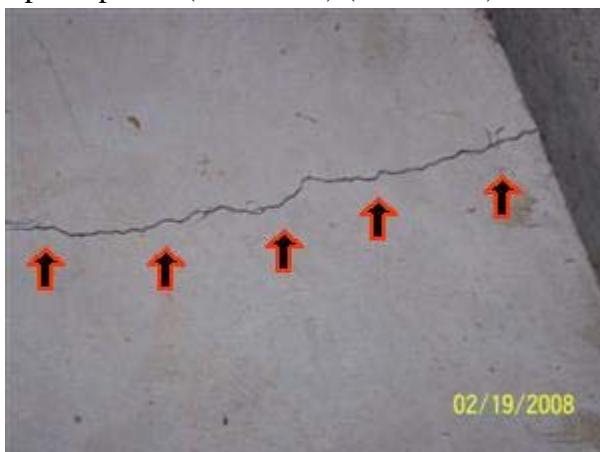
3.3 Picture 1

- 📌 Several large cracks were noted in the basement floor. Recommend further evaluation by a structural engineer or qualified contractor to determine the extent of damage and suggest possible repair options.(Picture 1) (Picture 2)

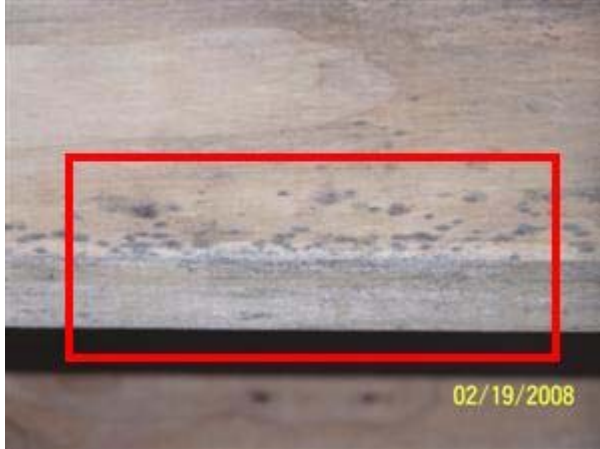
3.4 Picture 1

- 📌 Several floor joists towards the back side of the house were noted as having a distinctive leopard spot pattern. These patterns extended approximately three to four feet from the wall surface. Upon

close examination with a UV blacklight, these spots appeared to have a higher fluorescent reaction than the surrounding materials. Upon the clients request, a swab sample was obtained and sent to Pro-Lab, a state certified laboratory, to determine if the substance is mold.

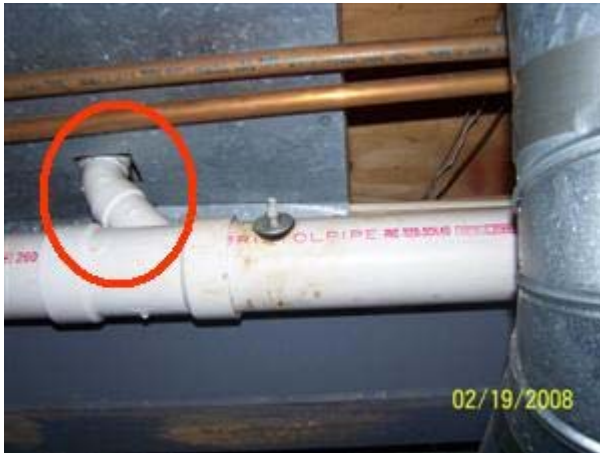
4.3 Picture 1

- 🏠 Upon inspection of the duct work for the heating and cooling system, a drain line was observed to penetrate the ducting system. A failure in the plumbing drain can lead to contaminating the air system. Improperly sealed ducting can draw in air from the basement area and circulate it throughout the house. Please refer to the section about Basement Ceilings regarding the possible mold like substance on the floor joists. Recommend repair and/or replacement by a qualified HVACR technician or sheet metal mechanic.

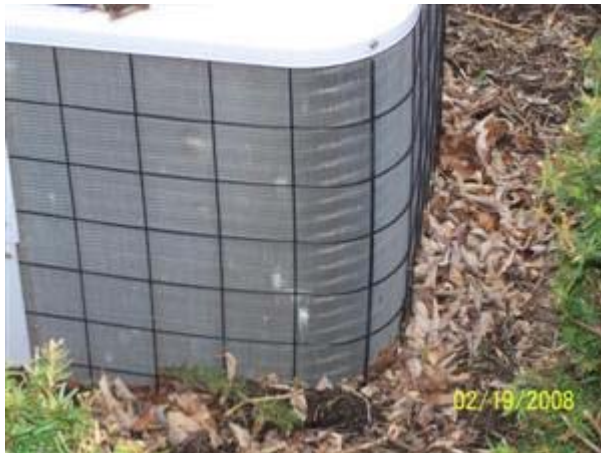
4.6 Picture 1

- 🏠 The central air conditioning compressor unit is positioned at ground level. Several areas are below the landscaped grade. Recommend the unit be placed above grade level.(Picture 1)

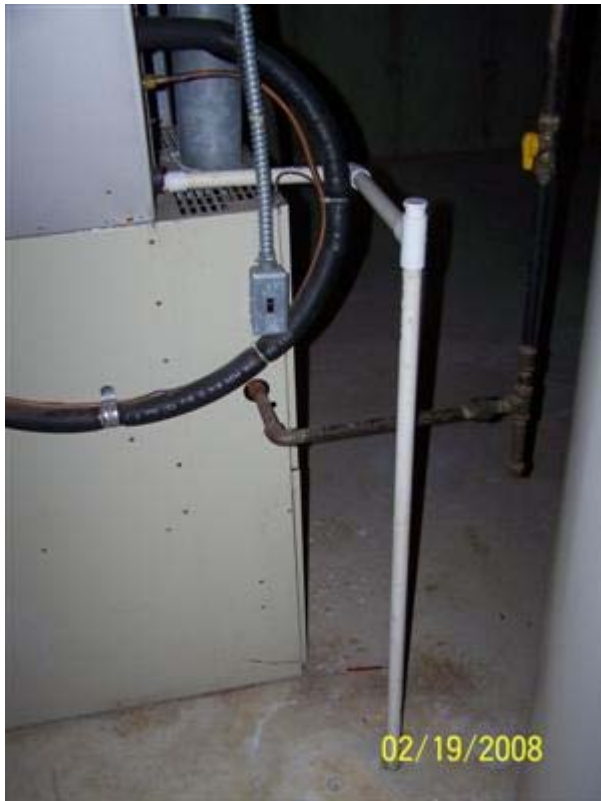
4.6 Picture 3

The air conditioning condensate line is positioned so that it drains through a hole drilled in the basement floor that does not appear to provide adequate drainage. Risk of insect or mechanical blockage as well as the possible erosion to the soil under the floor system is possible. This particular defect is suspiciously close to the cracks noted in the middle of the basement floor and the large crack in the foundation wall. Possible erosion may have already occurred. Recommend consulting a structural engineer and also recommend repair and replacement by a qualified HVACR technician. (Picture 3)

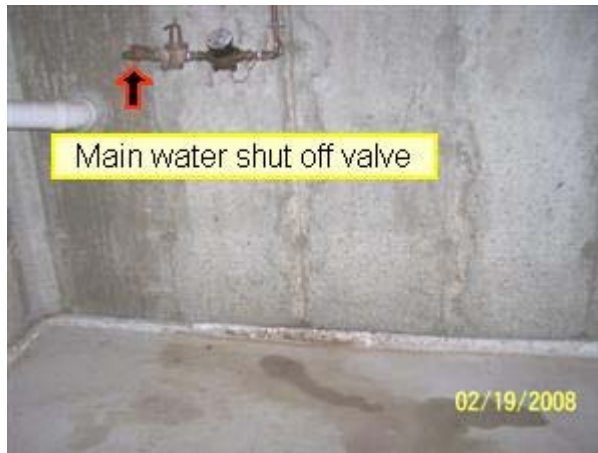
5.0 Picture 1

The main water supply shut off valve is located in the basement towards the front of the house. (Picture 1) The fitting immediately after the electronic water meter was noted as leaking. (Picture 2) Recommend repair by a qualified plumber.

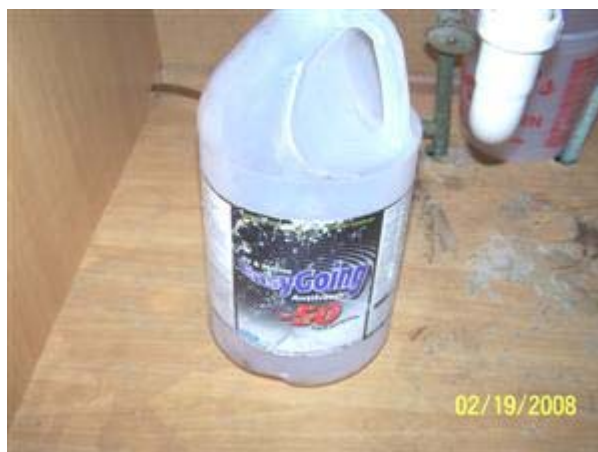
5.1 Picture 1

- 🏠 The plumbing system was previously winterized and the water supply was turned on the morning of the inspection. An empty jug of marine and RV rated antifreeze was found under the kitchen sink during the course of inspection. Recommend that the system be thoroughly flushed out and inspected by a plumbing contractor that specializes in winterization techniques.(Picture 1)

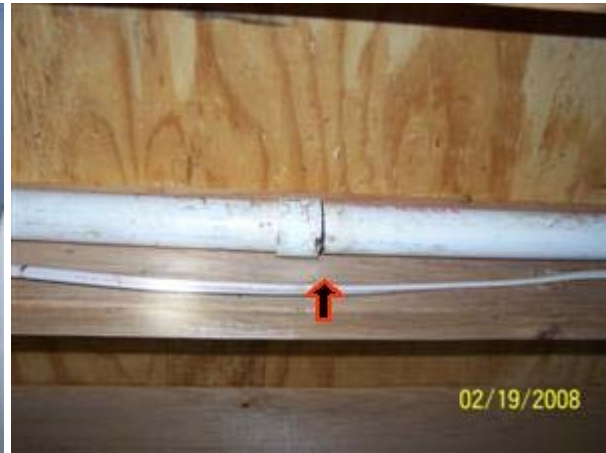
5.1 Picture 4

The drain line located in the basement for the kitchen sink was observed to be leaking at a coupling fitting. (Picture 4) This was probably the result of the drain line being unsupported due to a broken support strap. (Picture 7) Recommend repair by a qualified plumber.

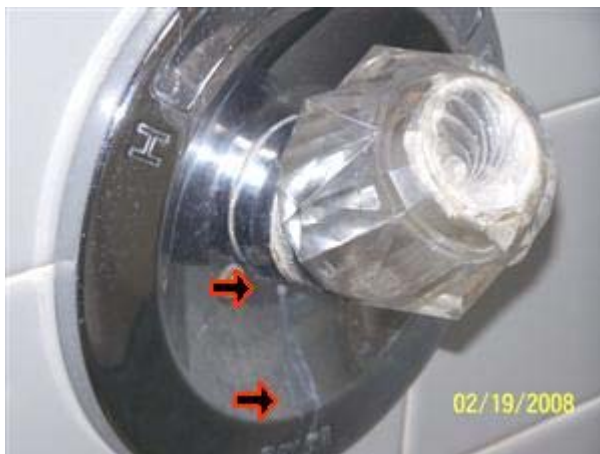
5.2 Picture 1

The upstairs shower valve was noted as leaking. (Picture 1) Recommend repair or replacement as needed.

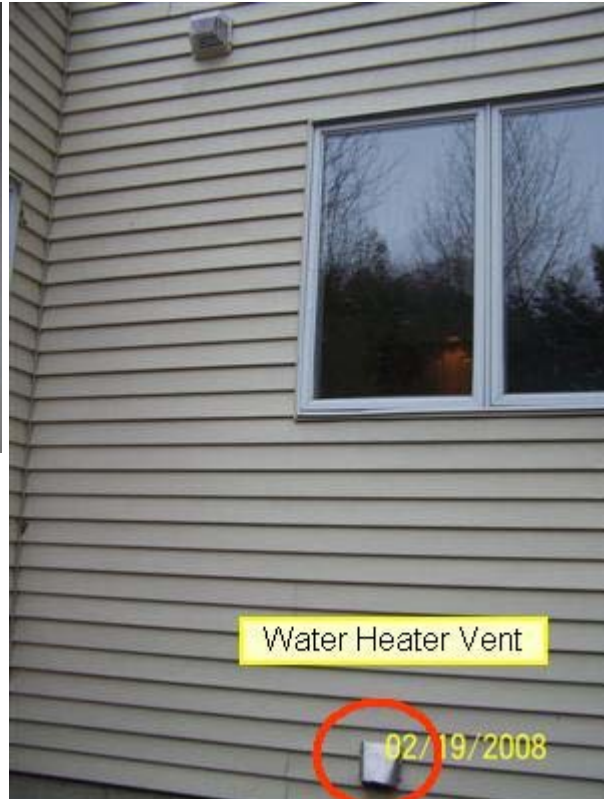
5.3 Picture 2

the water heater vent is located at the rear of the house. Caution should be taken to not block the exhaust vent and causing dangerous gases to accumulate in the house. Recommend diverting exhaust vent to ensure it does not become blocked by inadvertent placement of materials or by wildlife crawling inside vent housing.(Picture 2)

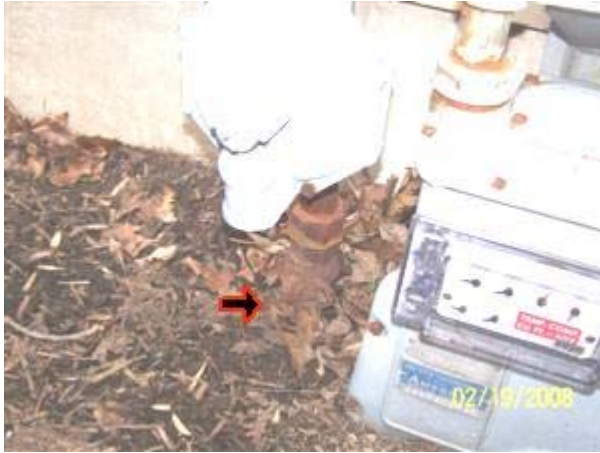
5.5 Picture 1

The main gas supply shut off valve is located at the left front corner of the house. Landscaping was noted as being in very close proximity to the valve. Signs of corrosion were noted. Recommend regrading the landscaping away from the supply lines and repair or replacement of the valve by a qualified plumber or contractor.(Picture 1)

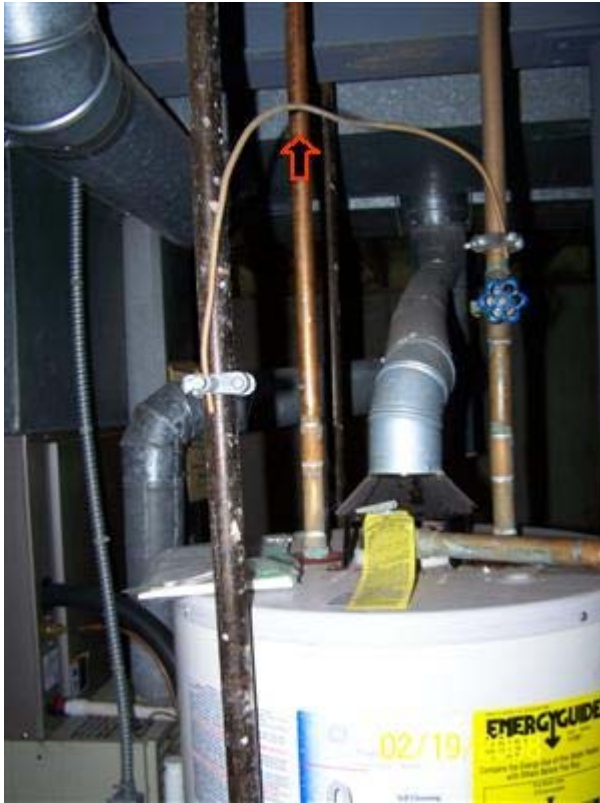
6.1 Picture 1

- 📌 The water heater was noted as not being properly bonded. Recommend repair by a qualified electrical contractor.(Picture 1)

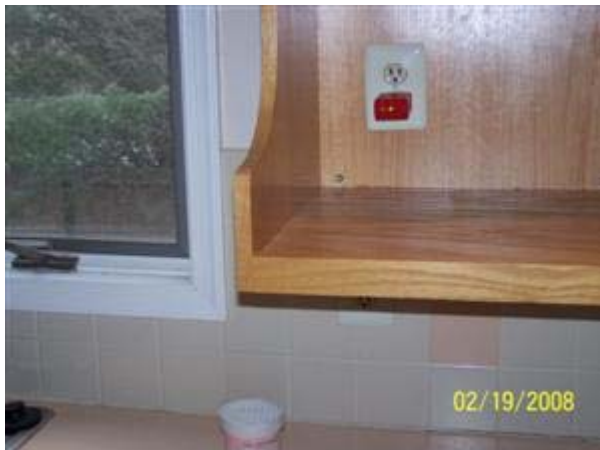
6.4 Picture 1

The outlet located inside the shelving unit in the kitchen was noted as not being GFCI protected. This outlet is within 6 feet of a water source. Recommend repair or replacement by a qualified electrical contractor.(Picture 1)

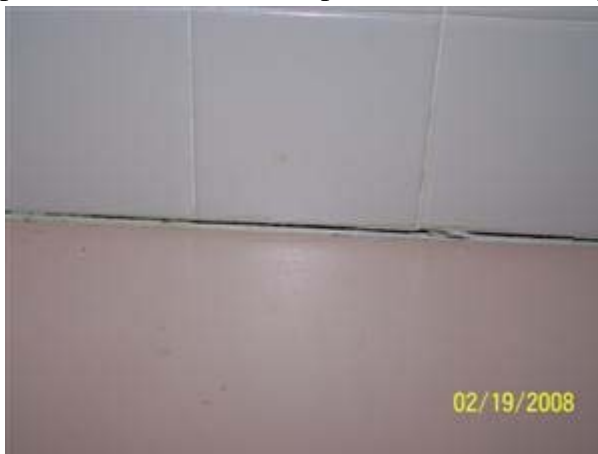
8.4 Picture 1

Bathroom counter tops were observed to have areas of cracked grout and peeling caulk. This is a potential water intrusion point. Recommend repair.(Picture 1) (Picture 2)

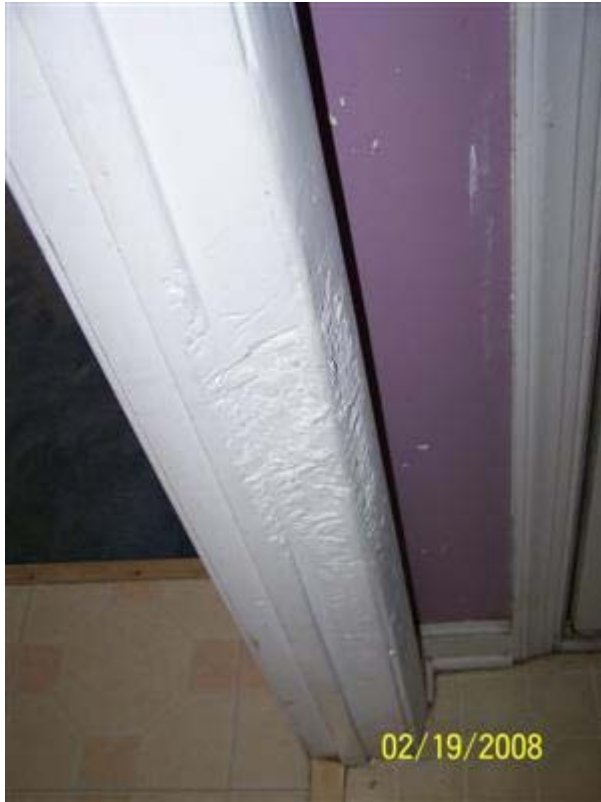
8.5 Picture 1

Several door frames were noted as being repaired by wood patching compound. Recommend repair or replacement as necessary.(Picture 1) (Picture 2) (Picture 3)

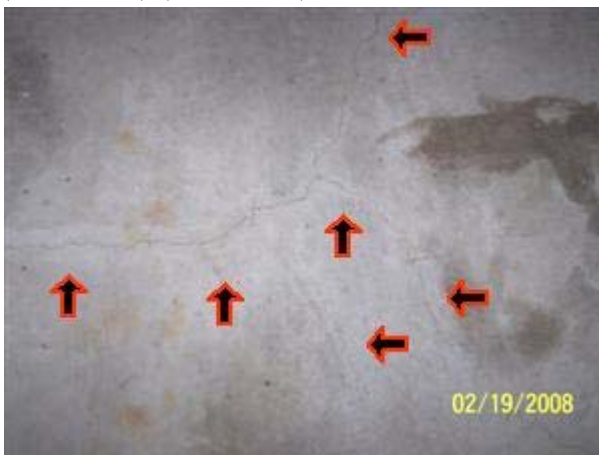
10.2 Picture 1

- 🏠 Several large cracks were noted in the garage floor. Recommend repair as needed.(Picture 1) (Picture 2) (Picture 3)

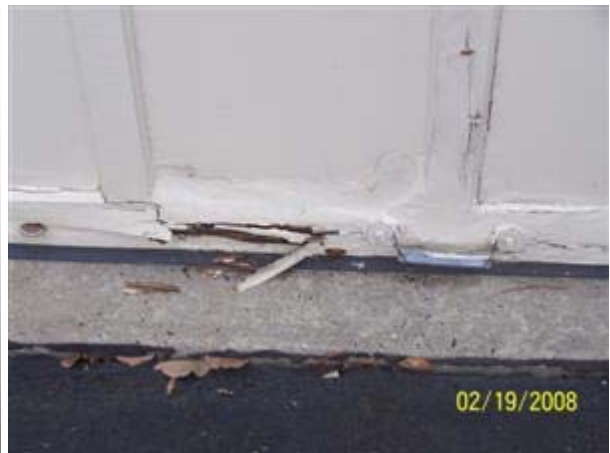
10.3 Picture 4

The bottom edge of the doors were noted as showing wood decay and fungal growth.(Picture 4) (Picture 5) (Picture 6) Recommend replacement of doors and hardware by a qualified contractor.

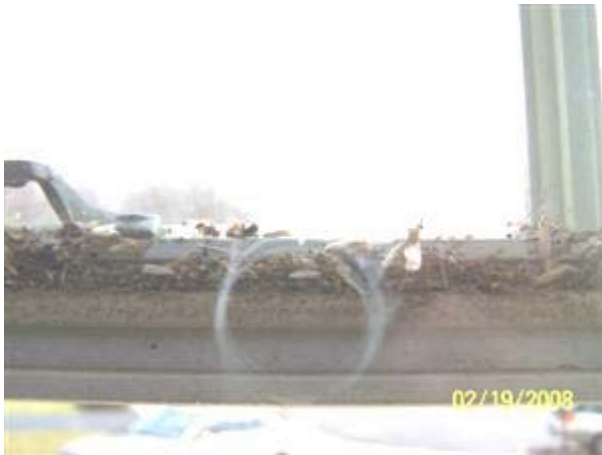
12.2 Picture 1

Several dead insects were found between the upper and lower windows of the garage. On close examination, they appeared to be a mixture of moths, beetles, and wasps. No obvious signs of termites or other wood destroying insects were noted.
