Inspection Report

Property Address:
123 Any Street
Philadelphia, PA 19147

Accuracy Assured Home Inspections

Date: 2/20/2008	Time: 12:00 PM	Report ID:
Property: 123 Any Street Philadelphia, PA 19147	Customer: Mr. Joe Homeowner	Real Estate Professional:

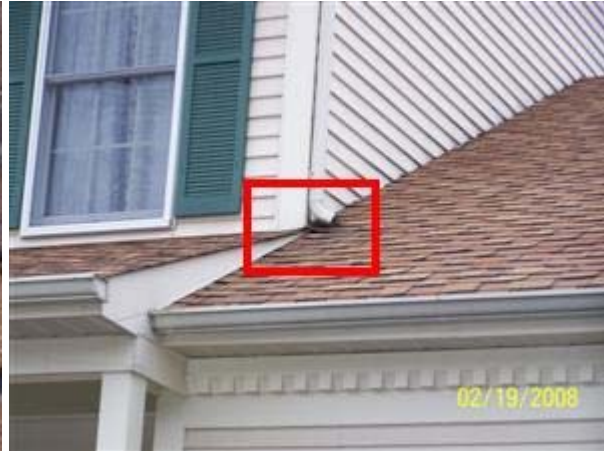
1.1 Picture 2

The flashing that was visible was inspected from the roof surface on the first level. The transition from the roof surfacing to the vertical structure was observed to be improperly sealed (Picture 1) (Picture 2) allowing a potential moisture access point. Recommend repair by a qualified roofing contractor or equivalent professional.

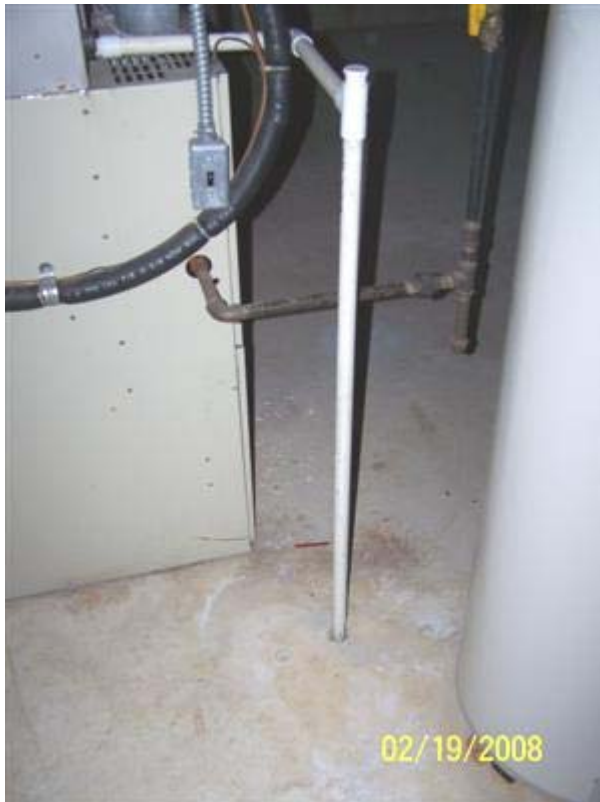
4.0 Picture 1

The heating equipment was inspected and appears to be functioning properly. An extensive inspection was not done to determine the the overall condition of the unit. Recommend having the system serviced by a qualified HVACR technician on a regular basis.

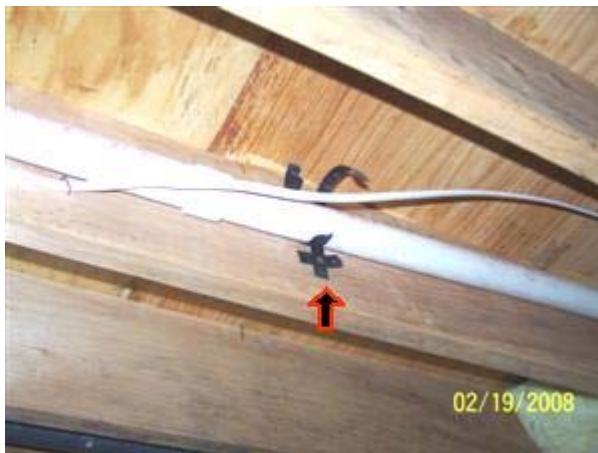
5.1 Picture 7

The drain line located in the basement for the kitchen sink was observed to be leaking at a coupling fitting. (Picture 4) This was probably the result of the drain line being unsupported due to a broken support strap. (Picture 7) Recommend repair by a qualified plumber.

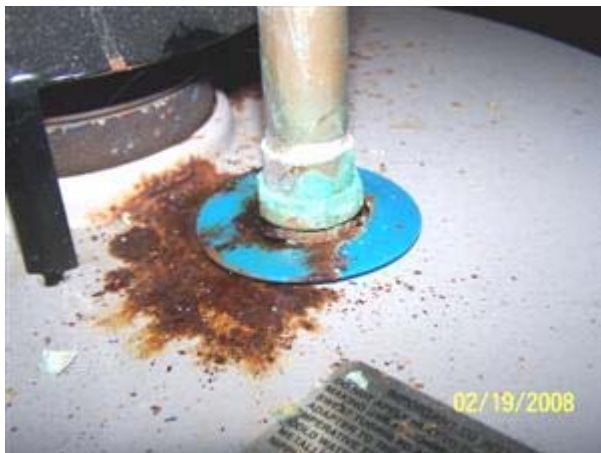
5.2 Picture 7

The water heater hot and cold water fittings were noted as showing signs of corrosion. When there hot water was turned on during the course of the inspection, rusty water was noted as coming out of the fixtures. Recommend evaluation by a qualified plumber or appliance technician. Repair or replace as needed.(Picture 7) (Picture 8)

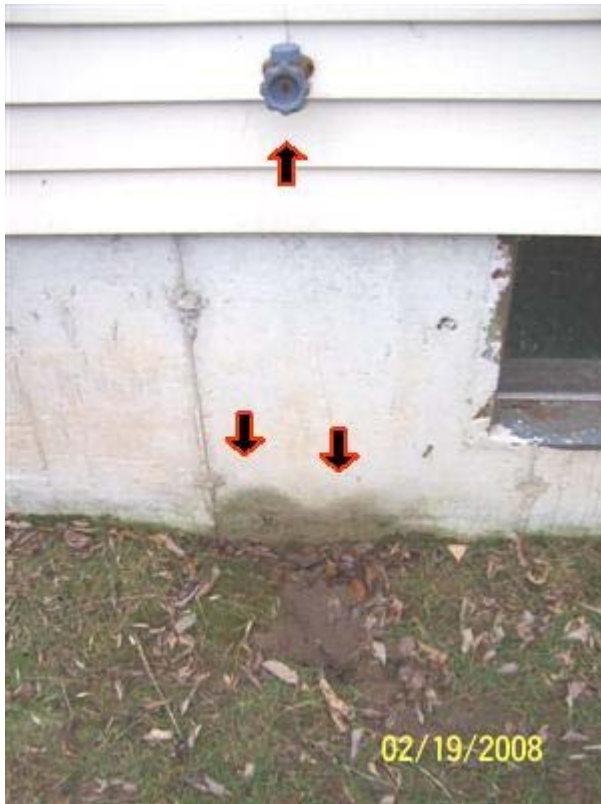
5.2 Picture 9

The hose bib at the back of the house was noted as leaking during the course of the inspection. I tried closing the valve and the faucet continued to drip. Evidence of erosion of landscaping is indicative of an ongoing problem. Recommend repair or replacement as needed.(Picture 9)

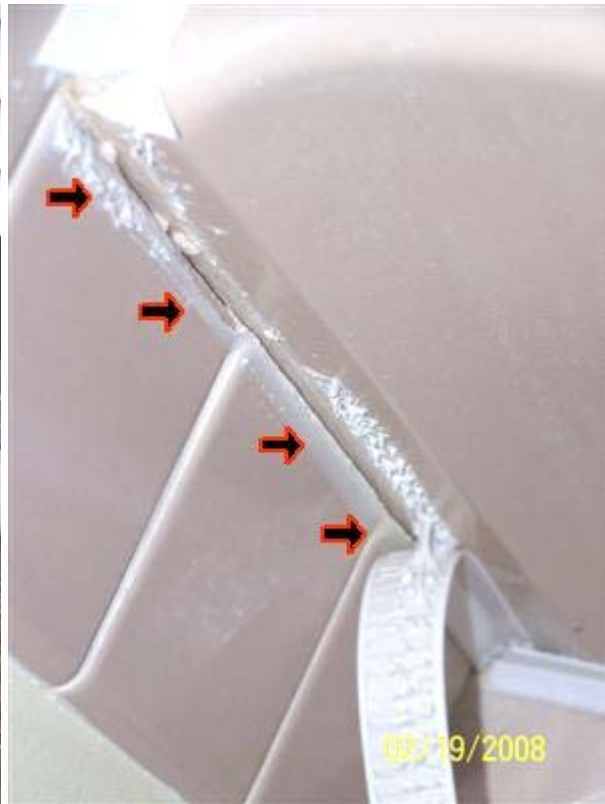
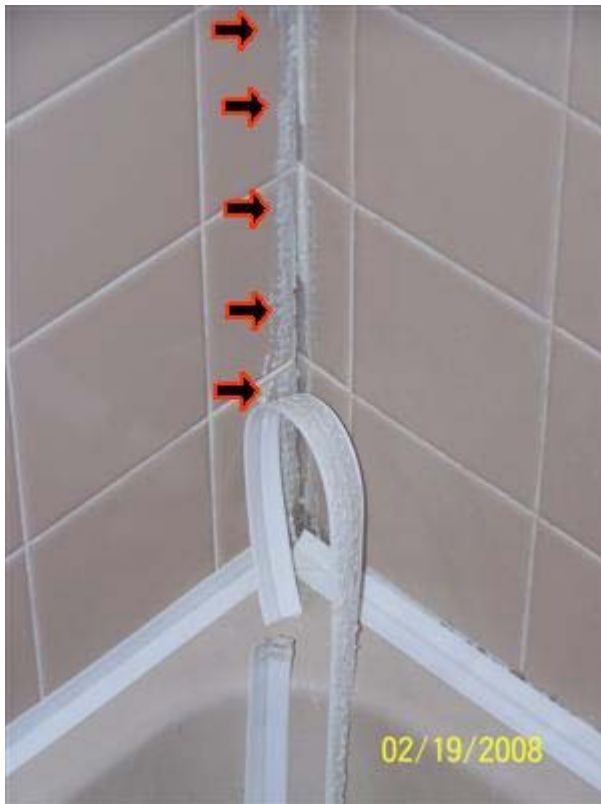
The tub and shower caulking was noted as peeling and large gaps in the grout underneath were exposed. The is a potential water intrusion point that can cause water damage to drywall, framing, and cause potential mold issues. Recommend repair or replacement as needed.(Picture 10) (Picture 11)

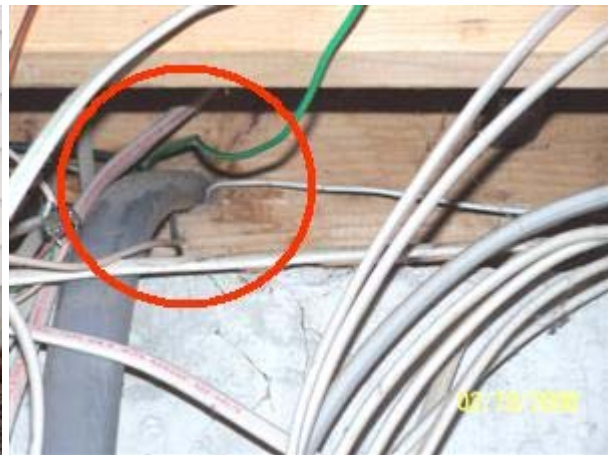
6.0 Picture 4

The penetration point where the electrical service lines enter the house were noted as being unsealed and uninsulated. Recommend sealing any gaps and insulating.(Picture 4)

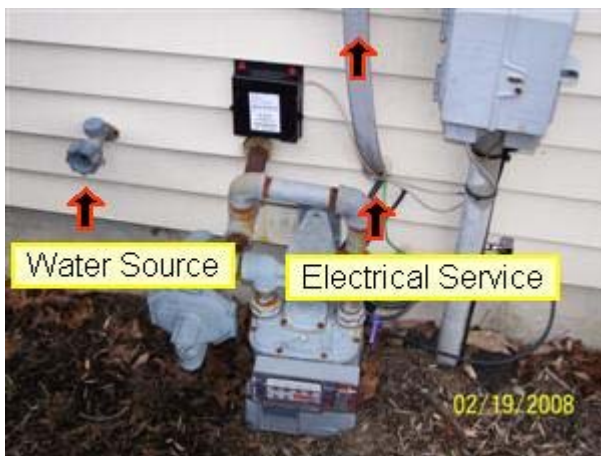
6.0 Picture 5

The electrical service lines are in very close proximity to an outside hose bib. Recommend relocation of the hose bib away from any electrical sources.(Picture 5)

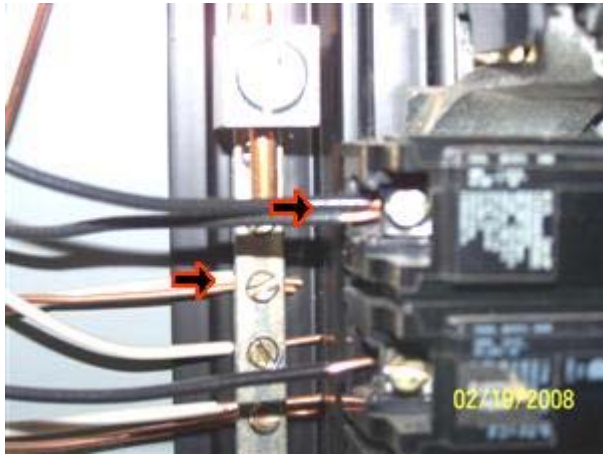
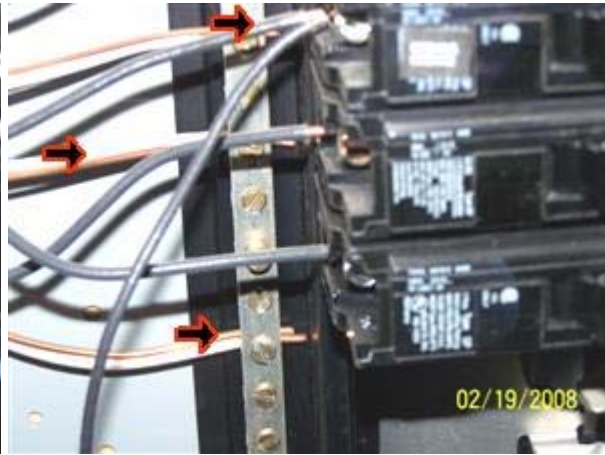
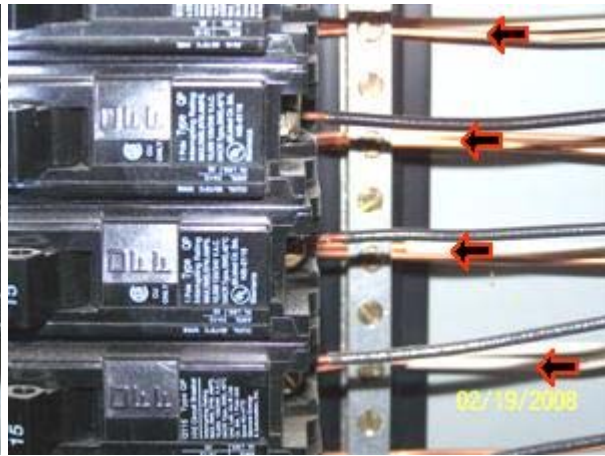
- 📌 Numerous double taps were observed when inspecting the branch wiring circuits inside the electrical service panel.(Picture 1) (Picture 2) (Picture 3) (Picture 4) Undergauged wiring was used on a 20 amp circuit breaker. Recommend repair and replacement by a qualified electrical contractor.(Picture 3)

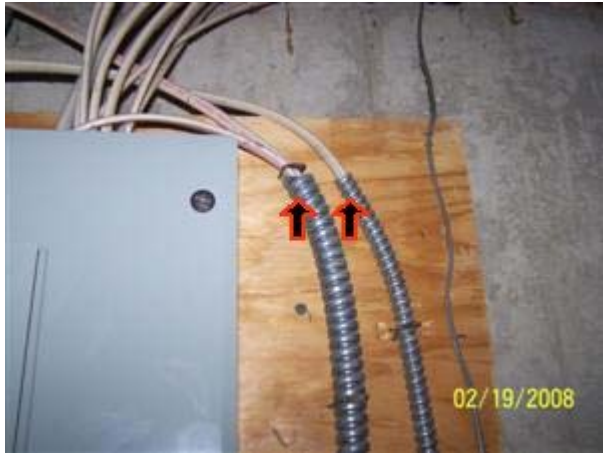
6.2 Picture 5

Flexible conduit was used to run Romex wiring throughout various locations throughout the house. Proper fittings were not used and wiring is exposed to the sharp edges of the flexible conduit. Sharp edges are a potential wear point on the insulation covering of the wiring and can cause a fire or electrocution hazard. Highly recommend repair or replacement by a qualified electrical contractor. (Picture 5) (Picture 6) (Picture 7)

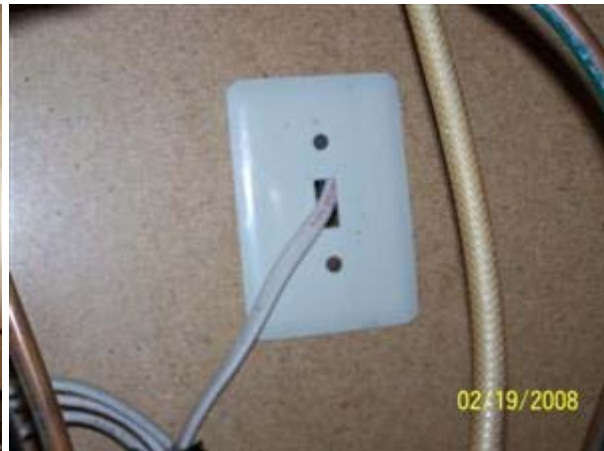
6.3 Picture 2

The electrical service lines for the installed garbage disposal are run through a light switch cover under the kitchen sink. Sharp edges are a wear point on the electrical wiring insulation and can cause a fire or electrocution hazard. Recommend repair or replacement by a qualified electrical contractor.(Picture 2)

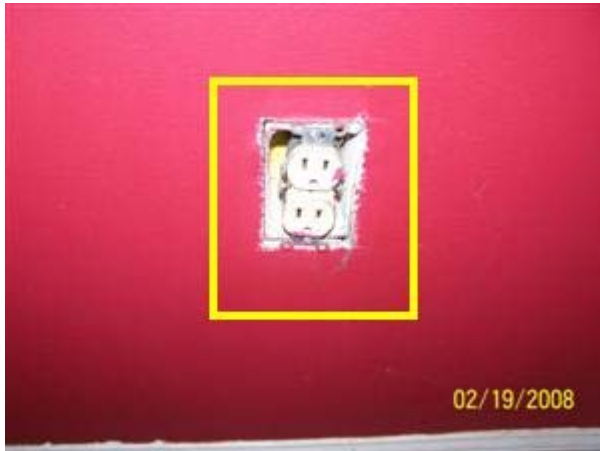
6.3 Picture 3

A missing outlet cover was noted in the front office space. Recommend repair and replacement. (Picture 3)

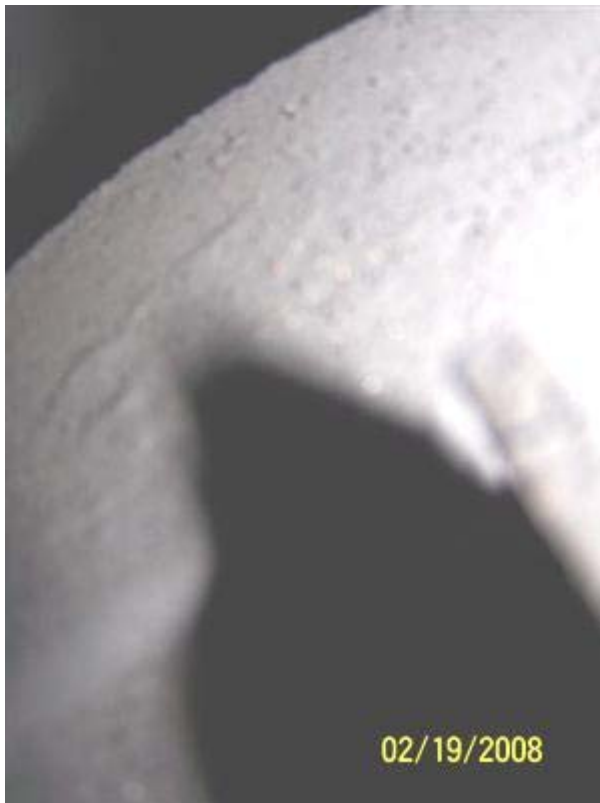
7.0 Picture 1

The chimney was inspected by opening the damper door and visually inspecting. Excessive buildup was noted on the lining of the chimney surface. Recommend cleaning by a qualified chimney sweep.(Picture 1) (Picture 2)

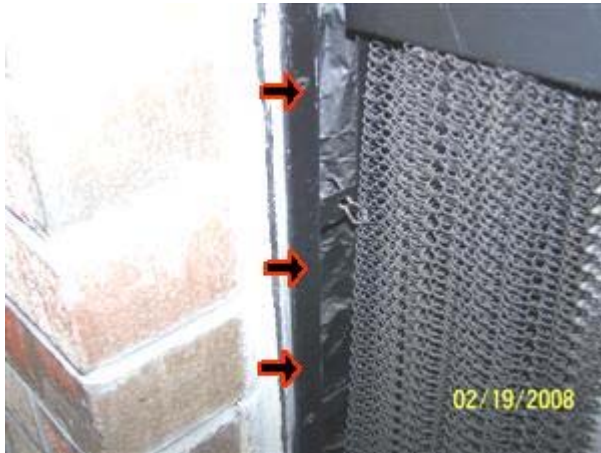
7.0 Picture 3

Visible insulation was observed on the side vents of the fireplace. Recommend evaluation by a qualified fireplace mechanic or chimney sweep.(Picture 3) (Picture 4)

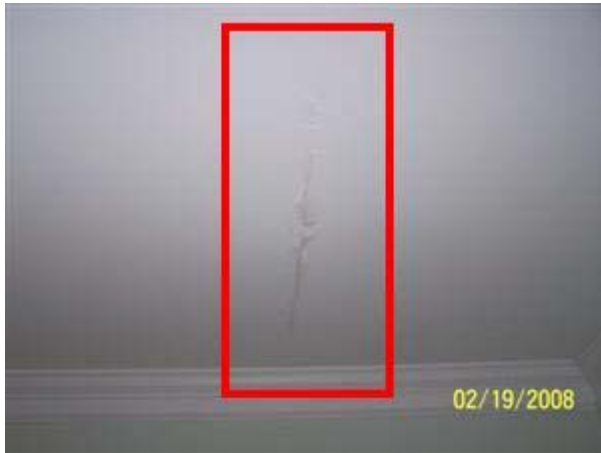
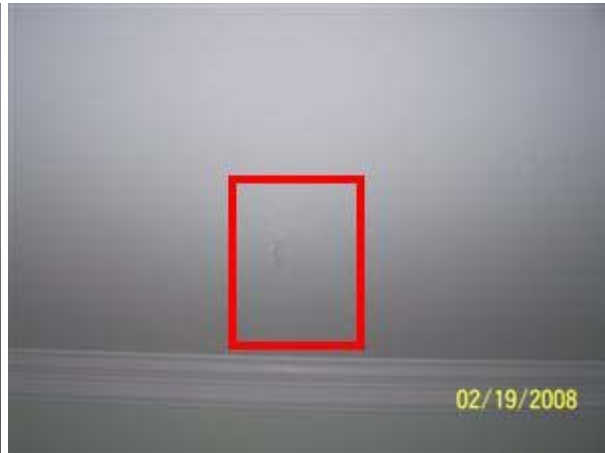
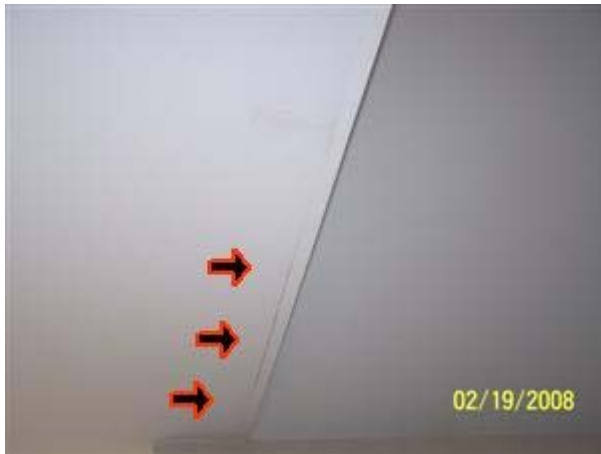
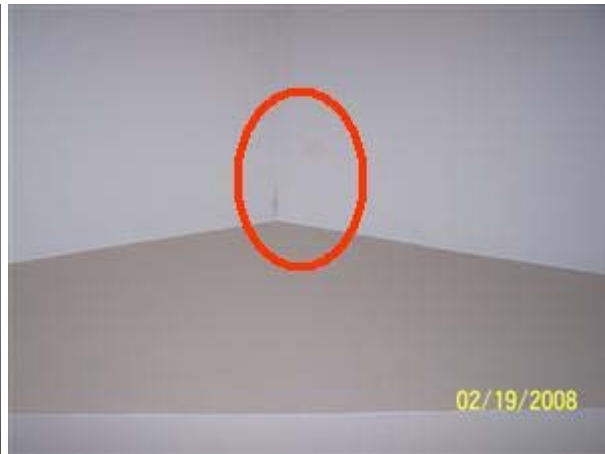
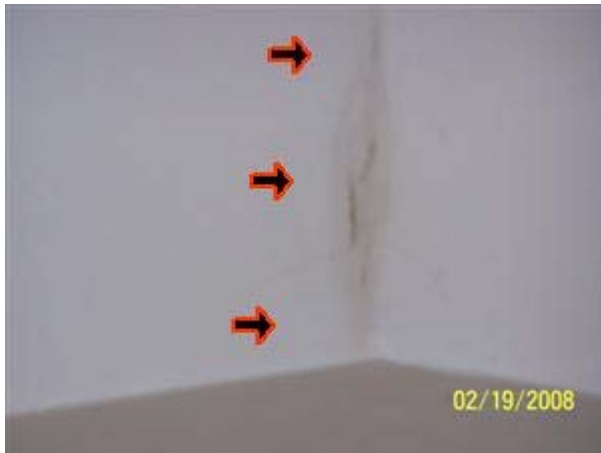
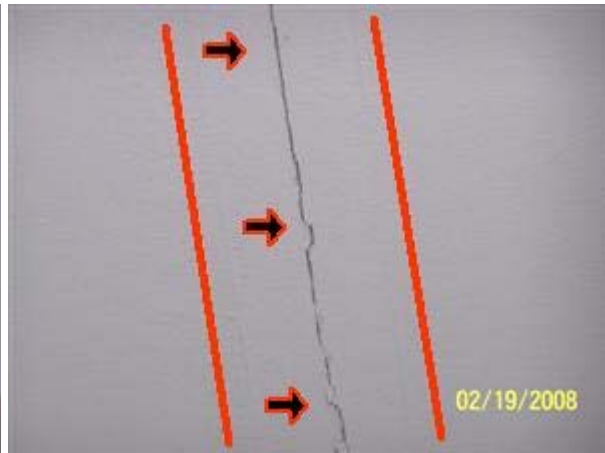
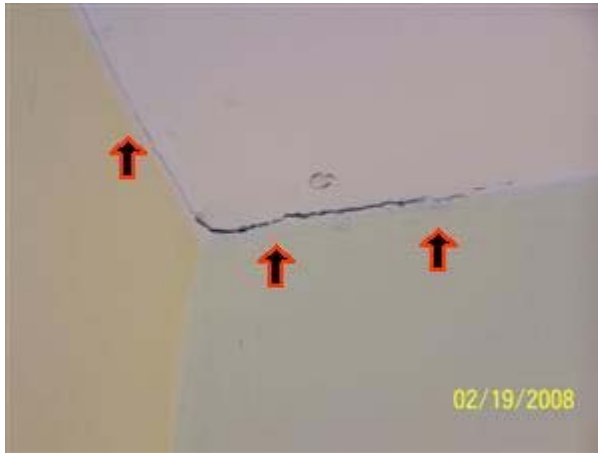
Numerous cracks were observed in the ceilings throughout the house.(Picture 1) (Picture 2) (Picture 3) (Picture 4) (Picture 5) (Picture 6) (Picture 7) Recommend repairing any leaks that may be contributing to cause some of these cracks.

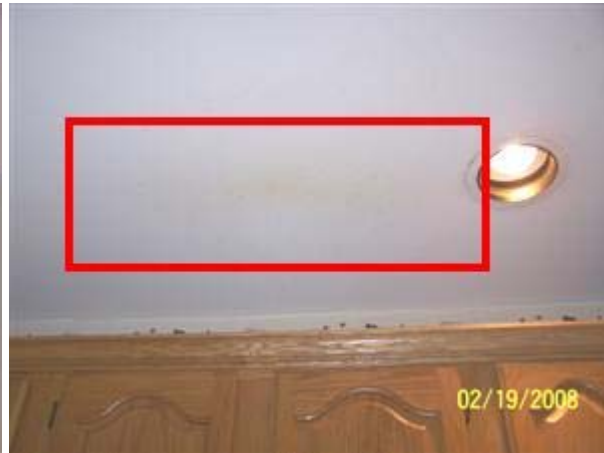
8.0 Picture 8

There was a large grease spot noted on the ceiling above the stove.(Picture 8)

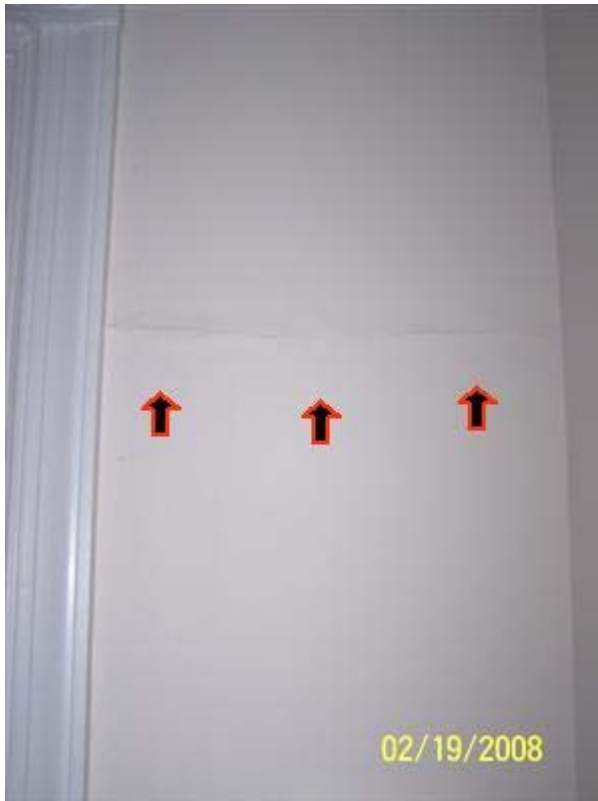
8.1 Picture 1

Several cracks were observed in the wall surfaces throughout the house.(Picture 1) (Picture 5)

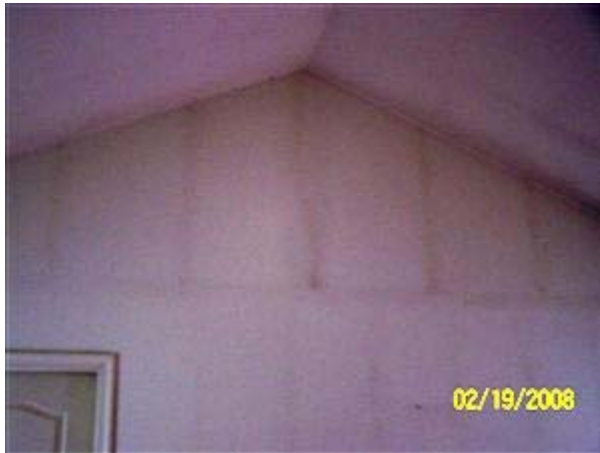
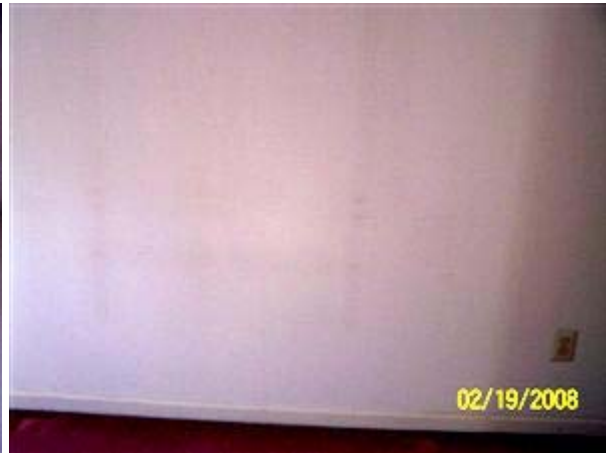
Ghosting was observed in numerous locations in the house. Suspect the fireplace was operated improperly or the damper door was not opened. Recommend primer and paint.(Picture 2) (Picture 3) (Picture 4)

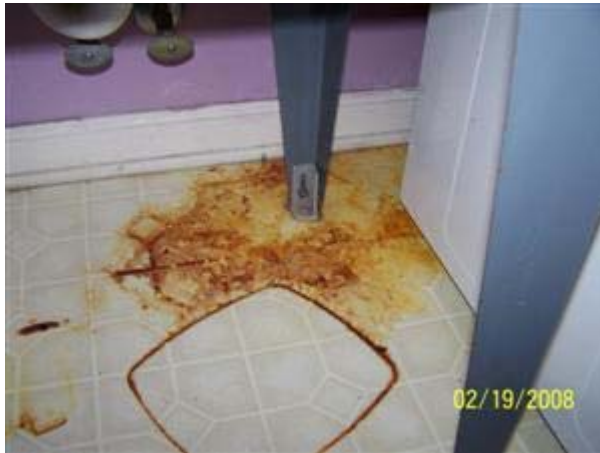
8.2 Picture 1

- 🏠 Staining was observed in the laundry room. Recommend cleaning, repair, or replacement as desired.(Picture 1)

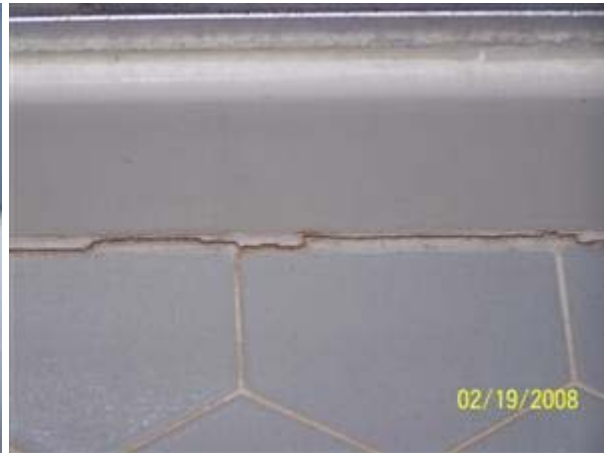
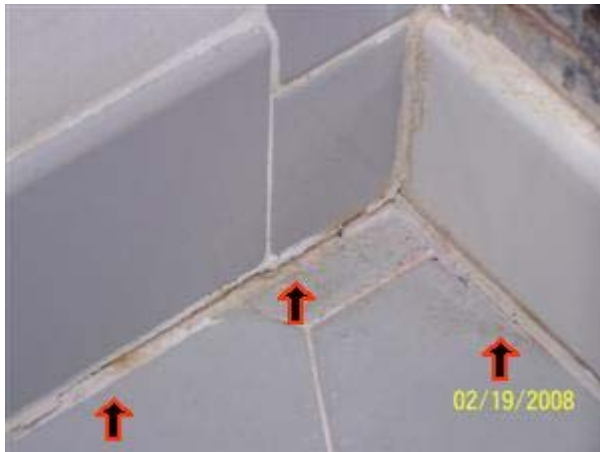
Some bathroom tiles were noted as being unsealed and cracked grout. This is a potential water intrusion point. Recommend repair or replace as necessary.(Picture 2) (Picture 3)

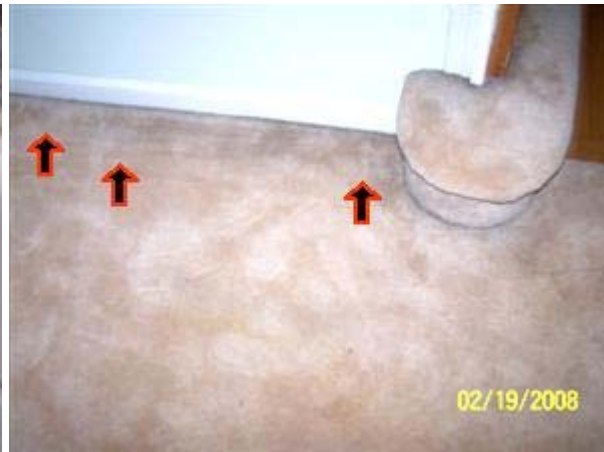
8.2 Picture 4

Carpet stained throughout house. Recommend replacement if desired.(Picture 4)

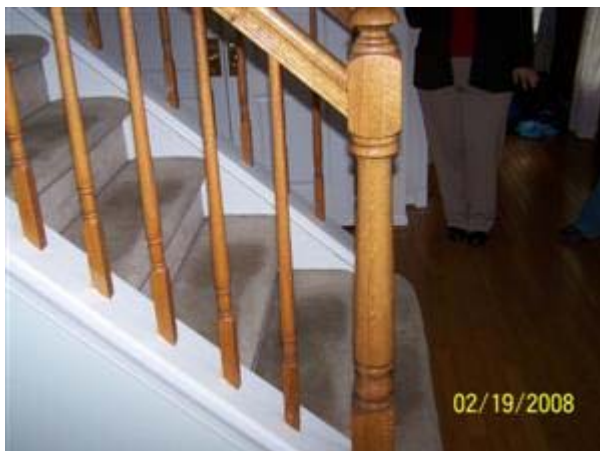
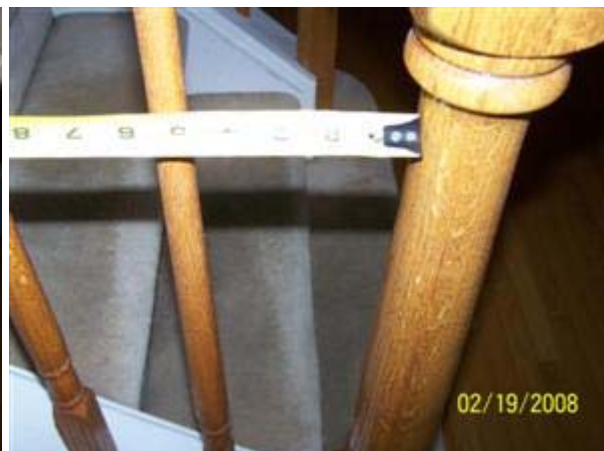
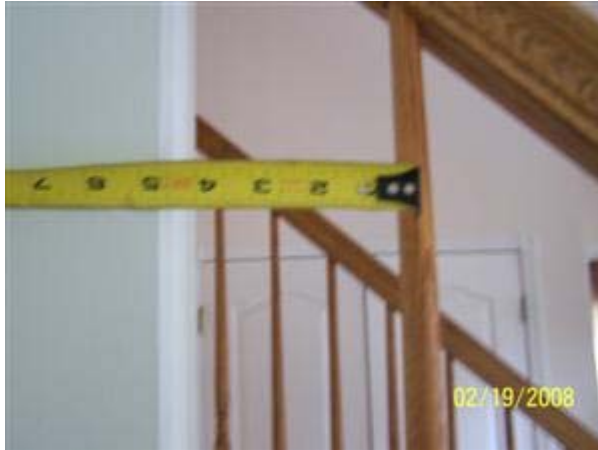
- █ The stair banister spindles are unevenly spaced and are have a 4 inch or wider opening. This is a potential safety issue for small children. Recommend repair or replacement.(Picture 1) (Picture 2) (Picture 3)

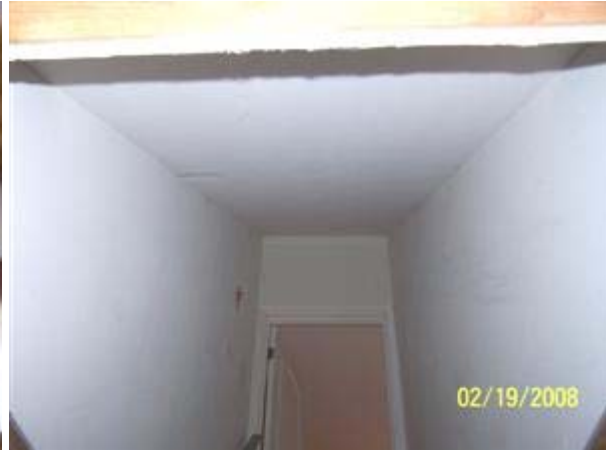
8.3 Picture 4

The basement stairwell does not have a light. Recommend installation of a light source at the top and bottom of the stairwell.(Picture 4)

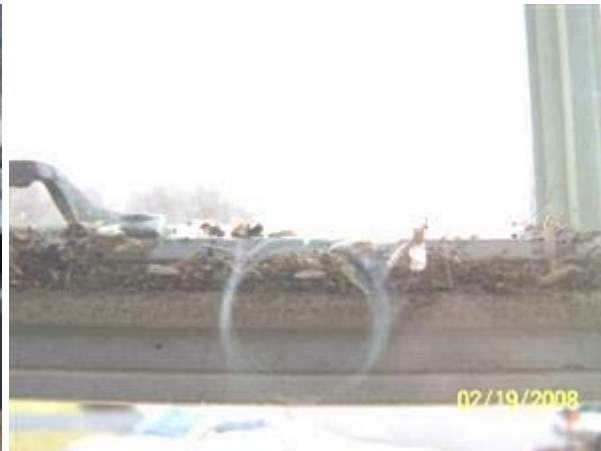
8.6 Picture 2

A large quantity of dead insects were observed in the space between the windows in the garage. Recommend cleaning to ensure proper operation of window.(Picture 2)

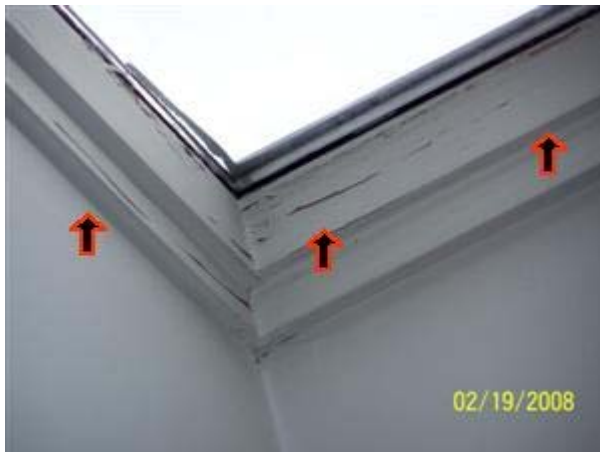
8.6 Picture 3

The skylights in the rear living room are were noted as having some splitting wood trim work and peeling paint. This is typical of water intrusion. Recommend repair or replacement to prevent further water intrusion.(Picture 3)

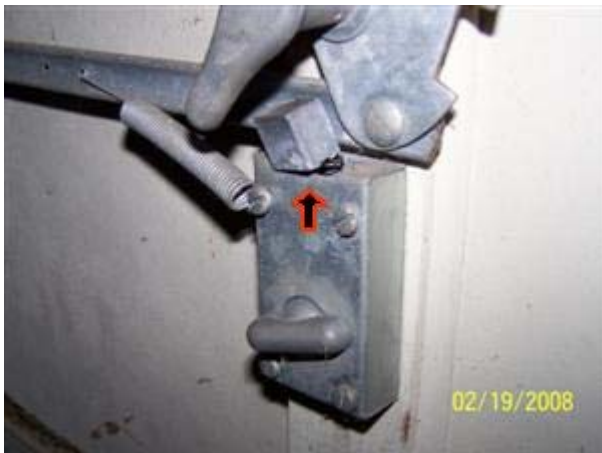
10.3 Picture 3

Door locks were noted as being broken.(Picture 3)

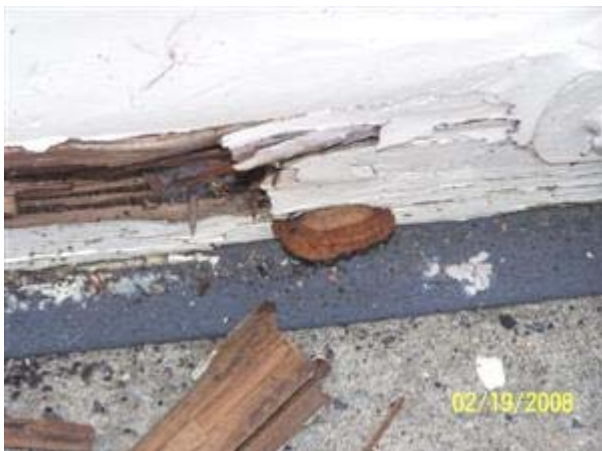
10.3 Picture 5

The bottom edge of the doors were noted as showing wood decay and fungal growth.(Picture 4) (Picture 5) (Picture 6) Recommend replacement of doors and hardware by a qualified contractor.
